GEOLOGICAL SURVEY OF OHIO

FOURTH SERIES, BULLETIN 18

BUILDING STONES OF OHIO

By J. A. BOWNOCKER

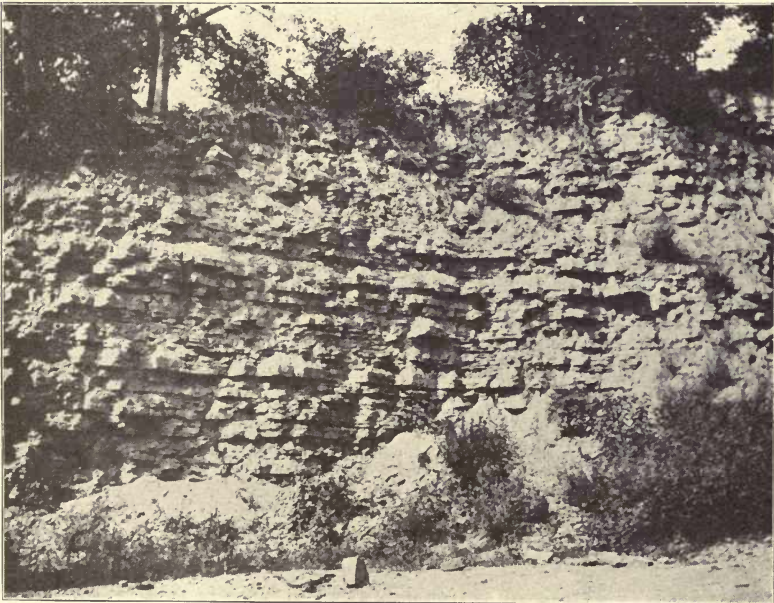
B.—View of Cincinnati limestone and shales (Lorraine formation), Cincinnati.
Note the large proportion of shales.

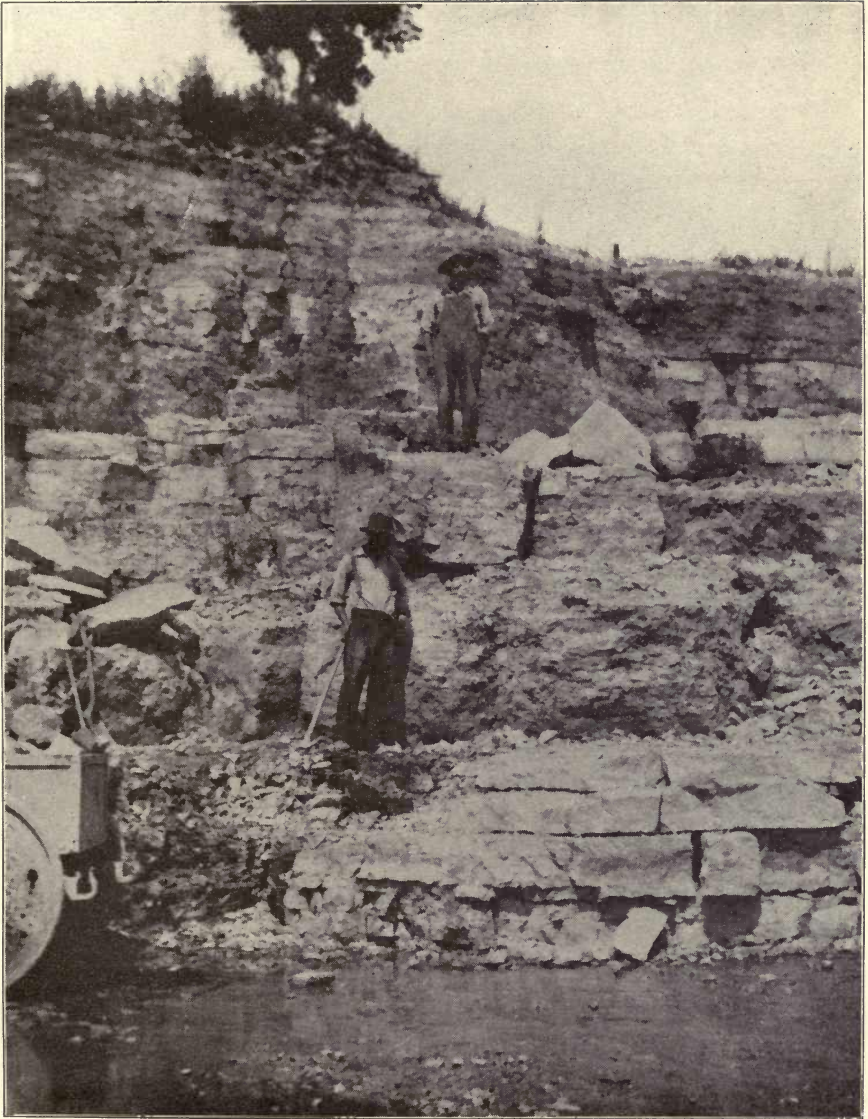
PLATE III.

Niagara limestone in the Robinson quarry, two miles south of Covington, Miami County. The lower man stands on top of the Osgood beds and to his back is the massive West Union limestone. The upper man stands on top of the West Union and to his back are the Springfield beds, the layers of which are not well shown. The broken rock under the tree forms the base of the Cedarville division of the Niagara.

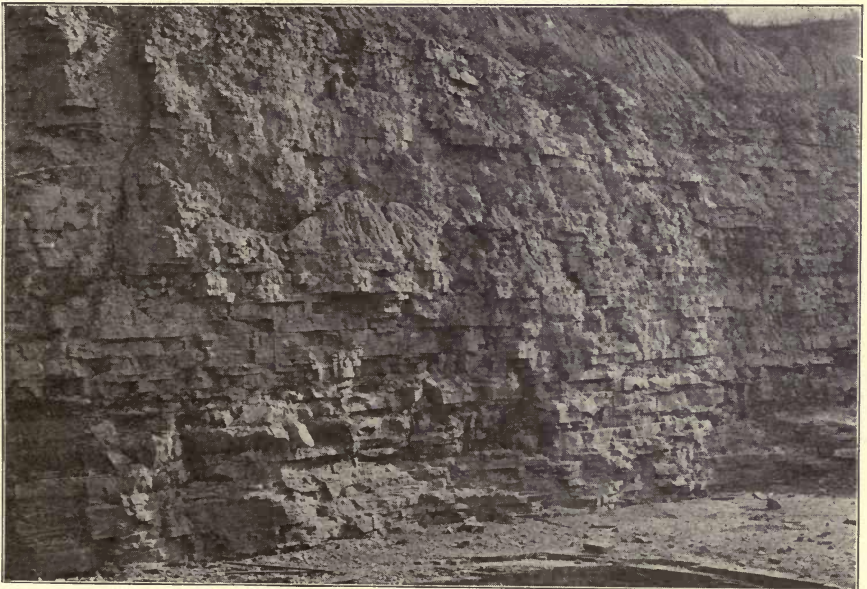
B.—View of the Monroe limestone in the Rucker quarry at Greenfield. Note the even layers. Photograph by C. W. Napper.

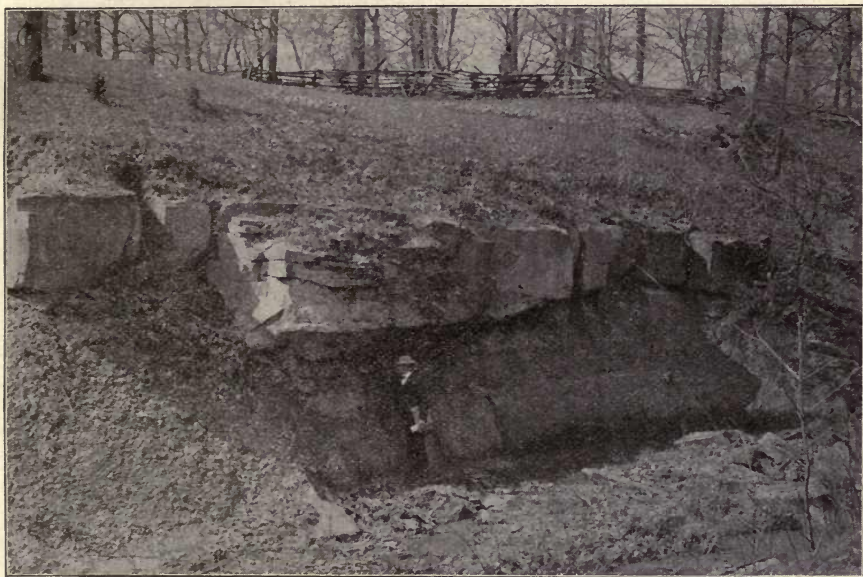
Fig. 4.—Entire section of Berea sandstone near Lithopolis. Note unconformity between sandstone and underlying Bedford shale. Photograph by H. A. Gleason.

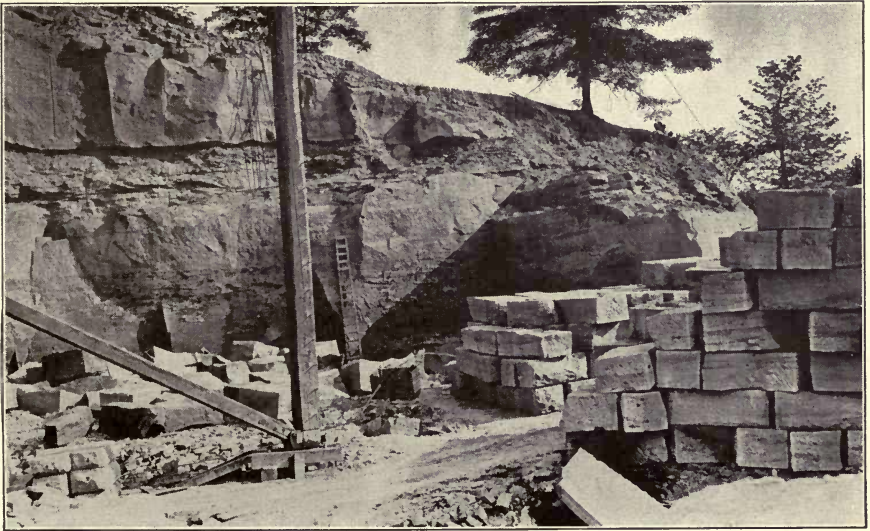
B.—Quarry in Mahoning sandstone at Corning, Perry County. The rock is used for bridges, foundations and viaducts. Photograph by D. D. Condit.
